CONNECTICUT COASTAL BASIN
EAST HAVEN-BRANFORD, CONNECTICUT
LAKE SALTONSTALL DAM
CT 00115

PHASE I INSPECTION REPORT
NATIONAL DAM INSPECTION PROGRAM

AUGUST, 1979

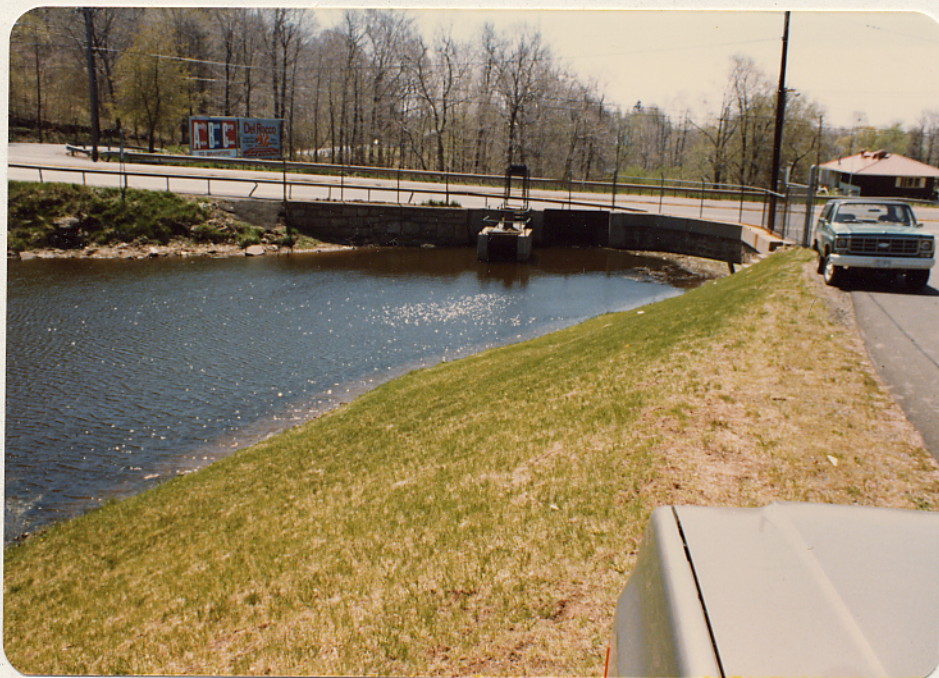
Crest - The crest of the earthfill dam accomodates U.S. Highway 1 (Photo 1). No misalignment of the crest was observed. Several cracks across the top were noted in the highway pavement which were most likely formed due to traffic loads.

PHOTO 1 - General view of upstream face of dam.

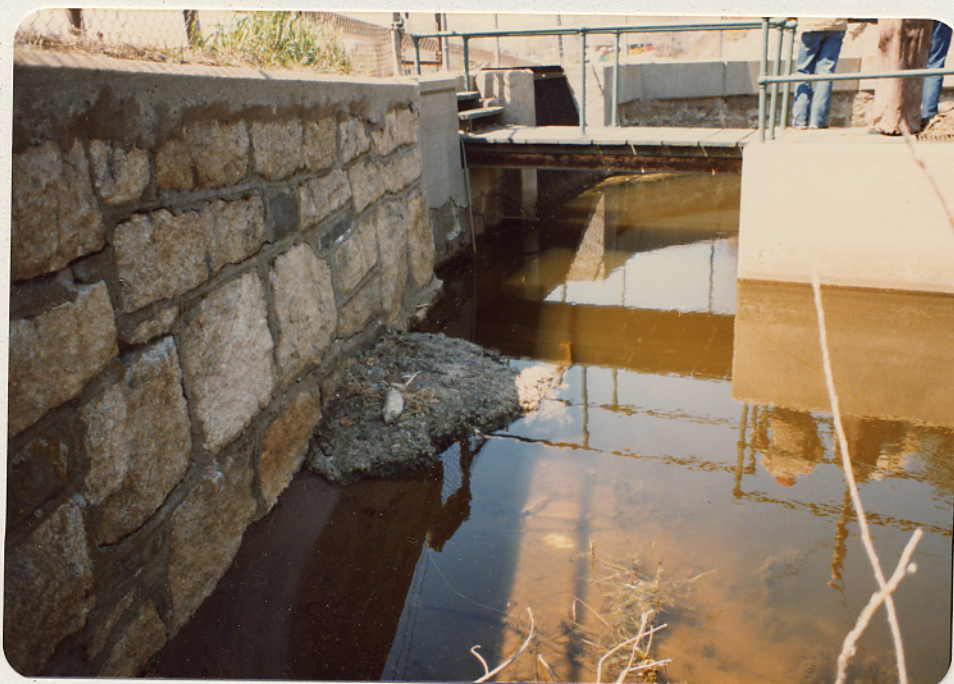
Upstream Face - The upstream face of the dam is a 2 foot wide and 60+ foot long masonry stone wall with cement mortar joints. The wall has a 2 foot wide and 2 foot high new concrete cap which was installed in 1960. The facing generally is in good condition. However, there were observed open joints in the left side of the wall, cracking in the mortar, and separating of distinct stones with 1/2 to 1 inch wide cracks between them near the water level (Photo 2). Several vertical 1/16 to 1/8 inch wide cracks were discovered in the corners of the concrete cap.

PHOTO 2 - Upstream stone masonry wall. Note spalling of concrete immediately to left of low level outlet gate access bridge.

4. The relatively minor cracking and spalling of the concrete of the spillway, service bridge abutment and outlet retaining wall, as well as the cracks in the stone masonry facing, should be repaired.

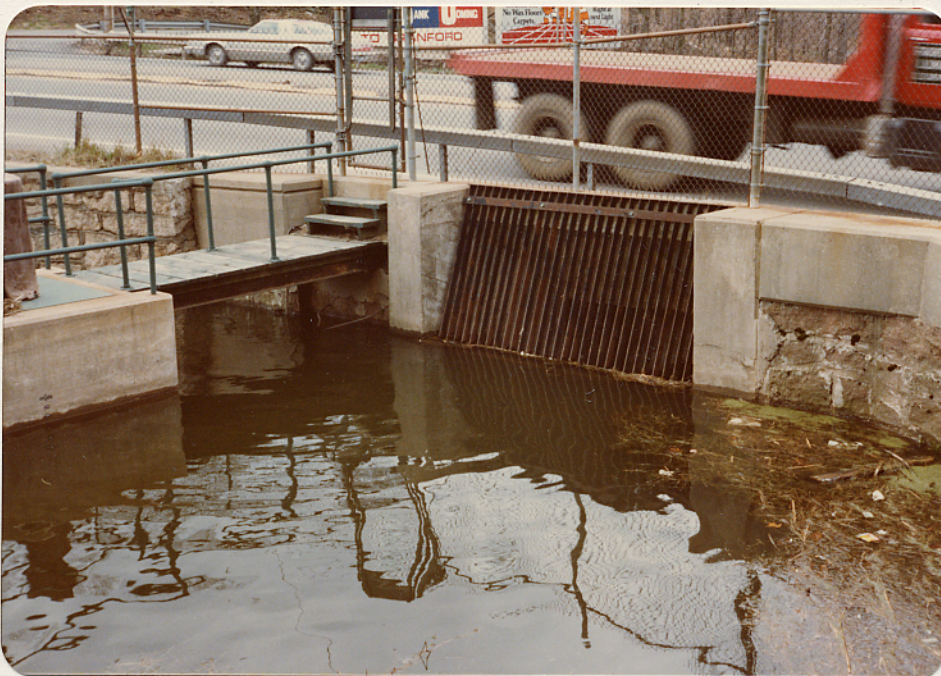
Spillway - The new cast-in-place reinforced concrete spillway built in 1960 has a 10 foot by 4.2 foot opening with a bar screen trash rack with bars spaced approximately every 2 inches (Photo 3). There was flow over the spillway during the inspection and hence it could not be observed completely. Spalling and cracking of the concrete were noted on the left side of the spillway and at the right headwall adjacent to the spillway (Photo 3). Due to the location of the deteriorated concrete, it appears that the damage was caused by freeze-thaw cycles.

PHOTO 3 - Close up of bar screen across spillway inlet.

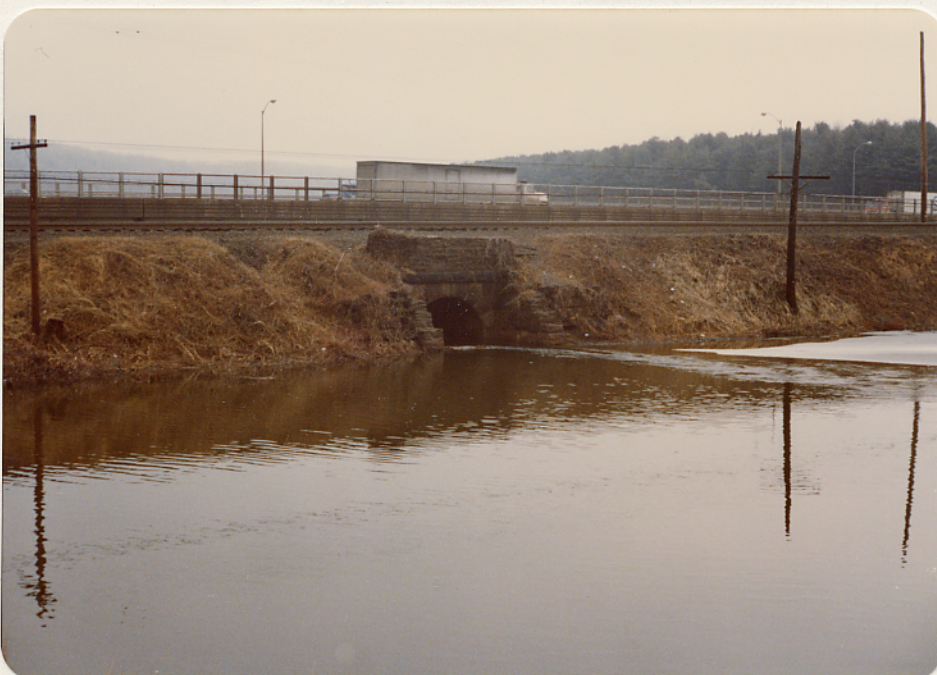
PHOTO 4 - Arch conduit through railroad embankment upstream of dam. Embankment acts as a constriction regulating flow to dam.

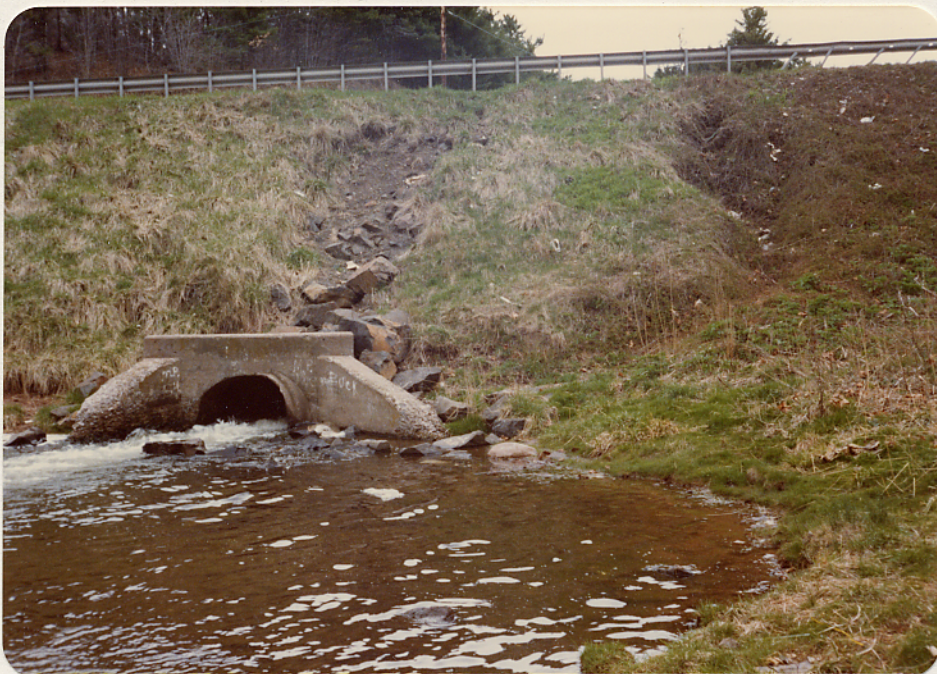
Downstream Slope - The downstream earth slope of the dam with an inclination of approximately 2 horizontal to 1 vertical is covered with tall grass and some brush. Two erosion ditches up to 1 to 2 foot deep and 2 to 3 feet wide were observed along the left side of the downstream slope at a distance of 30+ and 60+ feet from the concrete outlet, respectively (Photo 5). Because of the absence of a barrier, the downstream slope has numerous signs of trespassing, as well.

The concrete intake chamber is a concrete wet well with an intake opening to the 24 inch low level outlet pipe, which is connected to the junction box in the downstream portion of the highway embankment. There is a wooden plank service bridge between the chamber and the upstream face of the dam (Photo 2). At the downstream toe, there is a concrete low level outlet headwall, which exhibits deterioration of concrete particularly on the outlet wingwalls. This deterioration includes exposed aggregate, spalling, and a loss of the design shape due to the erosion of the wingwalls (Photo 5).

PHOTO 5 - Downstream slope and low level outlet conduit. Note sloughing and erosion of slope, and deterioration of outlet wingwalls.

5. Sloughing of the downstream slope should be repaired and appropriate measures taken to prevent further slope failures. Consideration should be given to the installation of a fence around the downstream slope and toe of the dam to prevent trespassing which has caused erosion problems on the downstream slope. Cutting of grass of the downstream slope and the toe should be performed regularly as part of the routine dam maintenance.

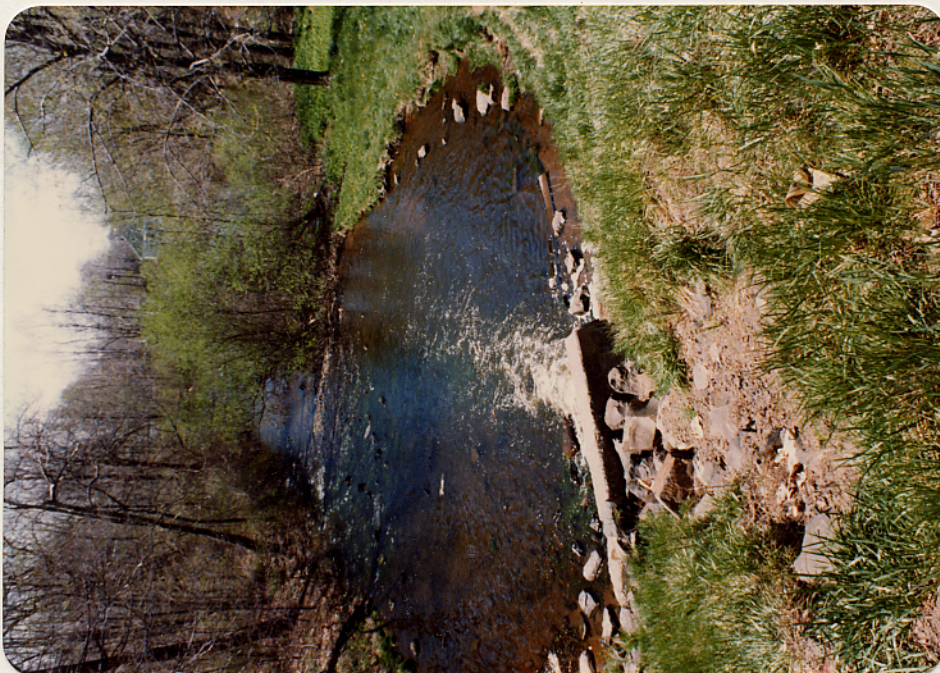
e. Downstream Channel - The downstream channel itself is in a fairly natural condition with a gravel and boulder bottom and trees and brush on its banks (Photo 6).

PHOTO 6 - View of downstream slope and channel from top of slope. Note erosion of slope.
